# Belvidere Park District Transition Plan

## Executive Summary

Prepared by:  
Accessibility Consultation and Training Services, Inc.

August 2025

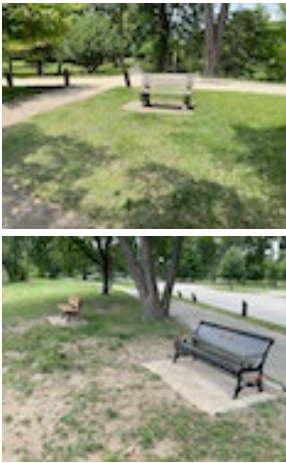
| Photo | Barrier | ADAAG/IAC | Solution | By Whom | Projected Cost | Projected Date | Action Taken |
|---|---|---|---|---|---|---|---|
| | There are approximately 7 benches that are not on an accessible route. | IAC 1011 | At two benches, provide a new accessible route with a running slope no steeper than 5% and a cross slope no steeper than 2% and a minimum clear width of 36 inches and connect to the companion seating of the bench. | | \$ 500.00 | | |

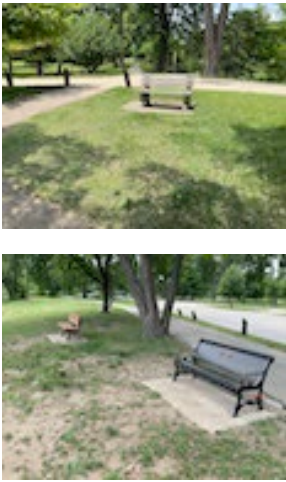
| Photo | Barrier | ADAAG/IAC | Solution | By Whom | Projected Cost | Projected Date | Action Taken |
|---|---|---|---|---|---|---|---|
| | There are approximately 7 benches that do not provide companion seating. | IAC 1011.2.1 | At two benches provide a clear ground space of at least 36 inches by 48 inches positioned near the benches with one side adjoining the walkway. The clear ground space should have a slope no steeper than 2% in all directions. The clear ground space should not overlap the accessible route or another clear ground space. | | \$ 750.00 | | |

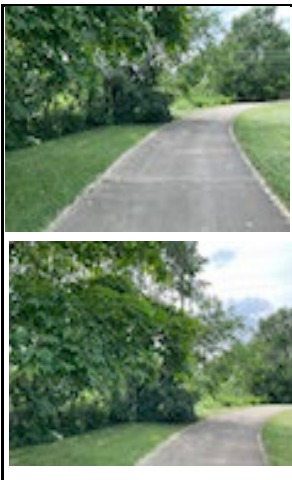
| | <p>Several branches along the walkway protrude at 70 inches AFF.</p> | <p>ADAAG 307</p> | <p>Trim the branch to provide an 80 inches minimum clear head space and back to the edge of the walkway.</p> | | <p>\$ 130.00</p> | | |

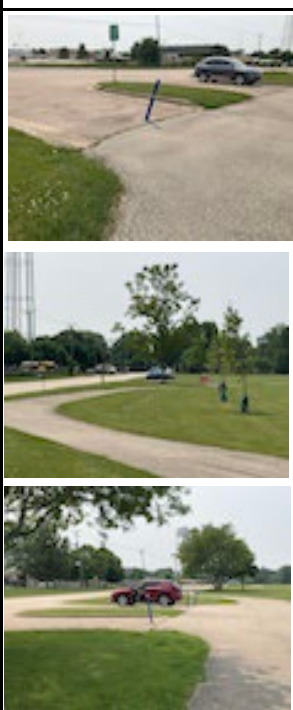
| | <p>The parking at the east end of the park does not provide accessible parking spaces. At least two accessible parking spaces would be required.</p> | <p>IAC 502</p> | <p>Provide two accessible parking spaces with an access aisle a minimum of 96 inches plus a sign with the International Symbol of Accessibility and a fine sign of \$250 to \$350 (Depending on local code) at the head and middle of the parking space at 5 feet minimum to a 9 feet maximum from the ground to the bottom of the sign and located no further than 6 feet in front of the parking space. The parking space and access aisle should be no steeper than 2% in all directions and on a firm and stable surface. Locate the accessible parking space on the shortest accessible route. <b>UD</b> - Provide a Universally Designed parking space with a minimum 11 foot (132 inches) parking space and a minimum 5 foot (60 inches) access aisle</p> | | <p>\$ 2,950.00</p> | | |

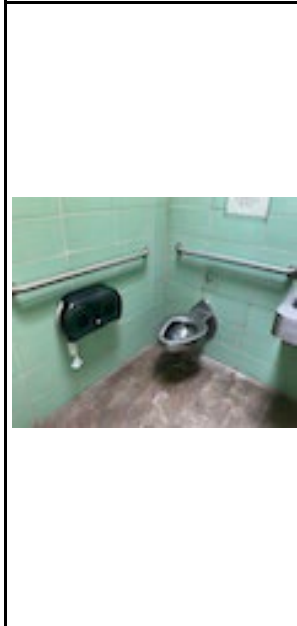
| | <p>The men's restroom toilet paper dispenser is too far in front of the toilet at 12 inches.</p> | <p>ADAAG 604.7</p> | <p>Remount the toilet paper dispenser to be no lower than 15 inches, no higher than 48 inches AFF and a centerline of the double roll dispenser that is a minimum of 7 inches to a maximum of 9 inches in front of the toilet. If above the grab bar provide at least 12 inches clearance between the grab bar and the bottom of the toilet paper dispenser. Do not mount the toilet paper dispenser behind the side grab bar. <b>Recommendation:</b> It would be recommended to mount the toilet paper dispenser 1 1/2 inches minimum under the side grab bar and no lower than 15 inches AFF.</p> | | <p>\$ 310.00</p> | | |

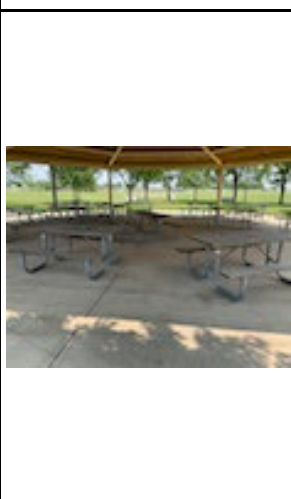
| | <p>The central picnic shelter has 16 picnic tables but none are of an accessible design.</p> | <p>IAC 245 &amp; IAC 1011</p> | <p>At least 20% of picnic tables be of an accessible design, connected to an accessible route. Provide picnic tables that have a clear floor space of 30 inches minimum by 48 inches minimum, a table top between 28 inches minimum of 34 inches maximum and a minimum 27 inches knee clearance. The knee clearance should go 17 inches to 25 inches under the top. Relocate or purchase four accessible picnic tables and locate them on an accessible surface.</p> | | <p>\$ 4,000.00</p> | | |

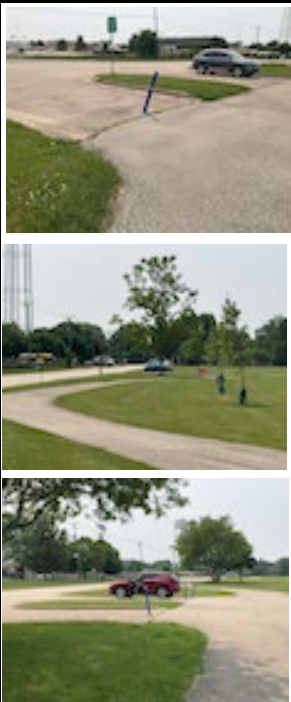
| | <p>The parking at the east end of the park does not provide accessible parking spaces. At least two accessible parking spaces would be required.</p> | <p>IAC 502</p> | <p>Provide two accessible parking spaces with an access aisle a minimum of 96 inches plus a sign with the International Symbol of Accessibility and a fine sign of \$250 to \$350 (Depending on local code) at the head and middle of the parking space at 5 feet minimum to a 9 feet maximum from the ground to the bottom of the sign and located no further than 6 feet in front of the parking space. The parking space and access aisle should be no steeper than 2% in all directions and on a firm and stable surface. Locate the accessible parking space on the shortest accessible route. <b>UD</b> - Provide a Universally Designed parking space with a minimum 11 foot (132 inches) parking space and a minimum 5 foot (60 inches) access aisle</p> | | <p>\$ 2,950.00</p> | | |

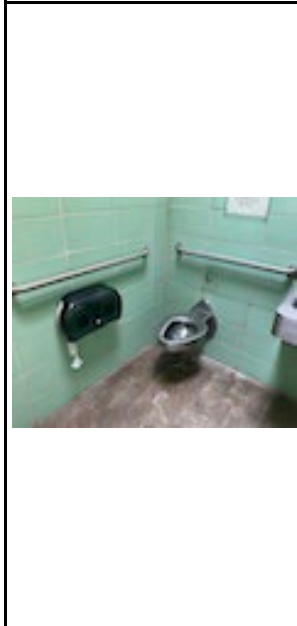
| | <p>The men's restroom toilet paper dispenser is too far in front of the toilet at 12 inches.</p> | <p>ADAAG 604.7</p> | <p>Remount the toilet paper dispenser to be no lower than 15 inches, no higher than 48 inches AFF and a centerline of the double roll dispenser that is a minimum of 7 inches to a maximum of 9 inches in front of the toilet. If above the grab bar provide at least 12 inches clearance between the grab bar and the bottom of the toilet paper dispenser. Do not mount the toilet paper dispenser behind the side grab bar. <b>Recommendation:</b> It would be recommended to mount the toilet paper dispenser 1 1/2 inches minimum under the side grab bar and no lower than 15 inches AFF.</p> | | <p>\$ 310.00</p> | | |

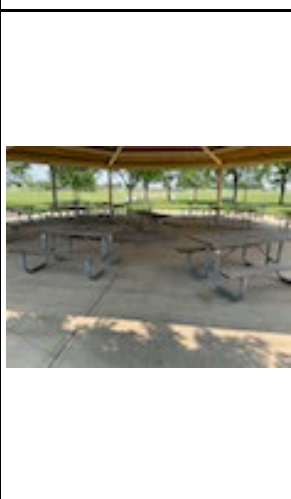
| | <p>The central picnic shelter has 16 picnic tables but none are of an accessible design.</p> | <p>IAC 245 &amp; IAC 1011</p> | <p>At least 20% of picnic tables be of an accessible design, connected to an accessible route. Provide picnic tables that have a clear floor space of 30 inches minimum by 48 inches minimum, a table top between 28 inches minimum of 34 inches maximum and a minimum 27 inches knee clearance. The knee clearance should go 17 inches to 25 inches under the top. Relocate or purchase four accessible picnic tables and locate them on an accessible surface.</p> | | <p>\$ 4,000.00</p> | | |

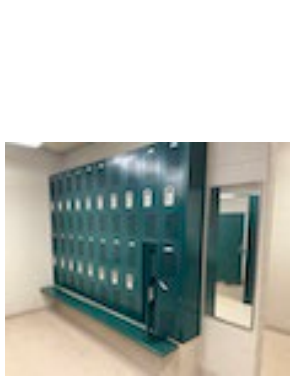
| | The men's locker-room does not provide an accessible changing bench. | ADAAG 222 & 903 | Provide a bench that is a minimum 42 inches long, and a minimum of 20 inches to a maximum of 24 inches deep. Provide a clear floor space at least 30 inches wide and at least 48 inches deep connected to the accessible route. The bench should be affixed to a wall or have a back support that extends at least 42 inches the length of the bench at a point a maximum of 2 inches above the seat. The accessible bench should be adjacent to the accessible lockers and have a seat between 17 inches to 19 inches AFF. | | \$ 955.00 | | |

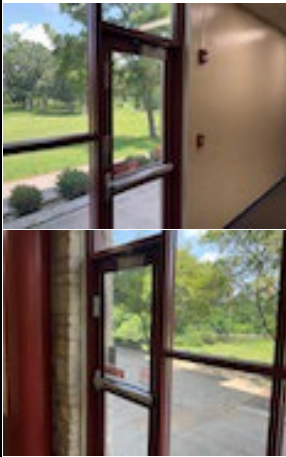
| | <p>The two exterior exit doors by the large multi-purpose room are alarmed but assume the door opening force is too high and/or closes too quickly.</p> | <p>IAC 404.2.9</p> | <p>Adjust the closer so the door opening force is no heavier than 8.5 lbs. to open and takes a minimum of 5 seconds to close or provide an automatic door opener at the door.</p> | | <p>\$ 250.00</p> | | |

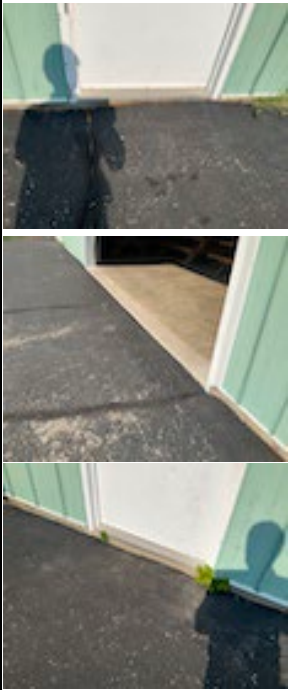
| Photo | Barrier | ADAAG/IAC | Solution | By Whom | Projected Cost | Projected Date | Action Taken |
|---|---|---|---|---|---|---|---|
| | There are abrupt transitions at the asphalt and concrete at all of the south pavilion doors that is too high at 1 inch or higher. | ADAAG 303 | Grind down and/or add more asphalt to provide a smooth transition. | | \$ 1,800.00 | | |
